PRODUCT NOTICE # 4-16-10-1

HDMI Resistor Patch Instructions

ConnectCore Wi-i.MX51

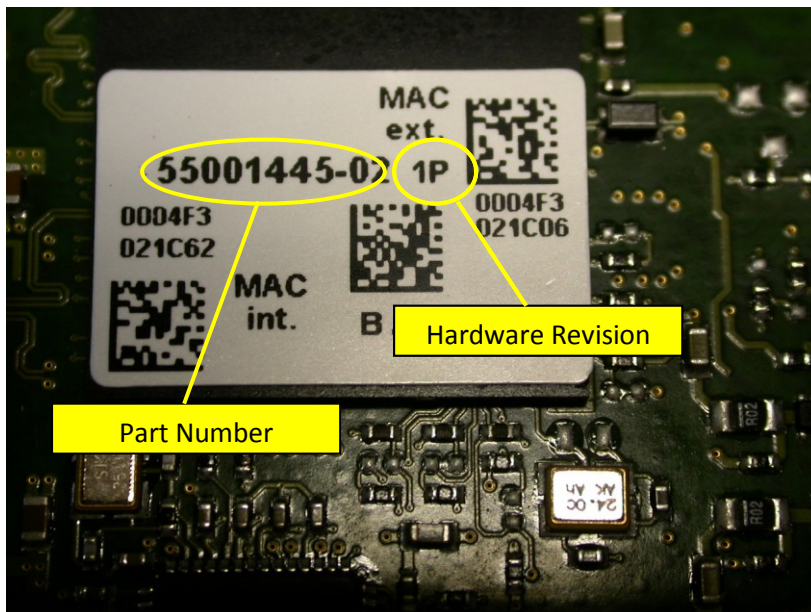
The issue applies to modules with Digi P/N **55001445-02** revision **1P** only.

Figure 1: Identify part number and hardware revision on label (top of module)

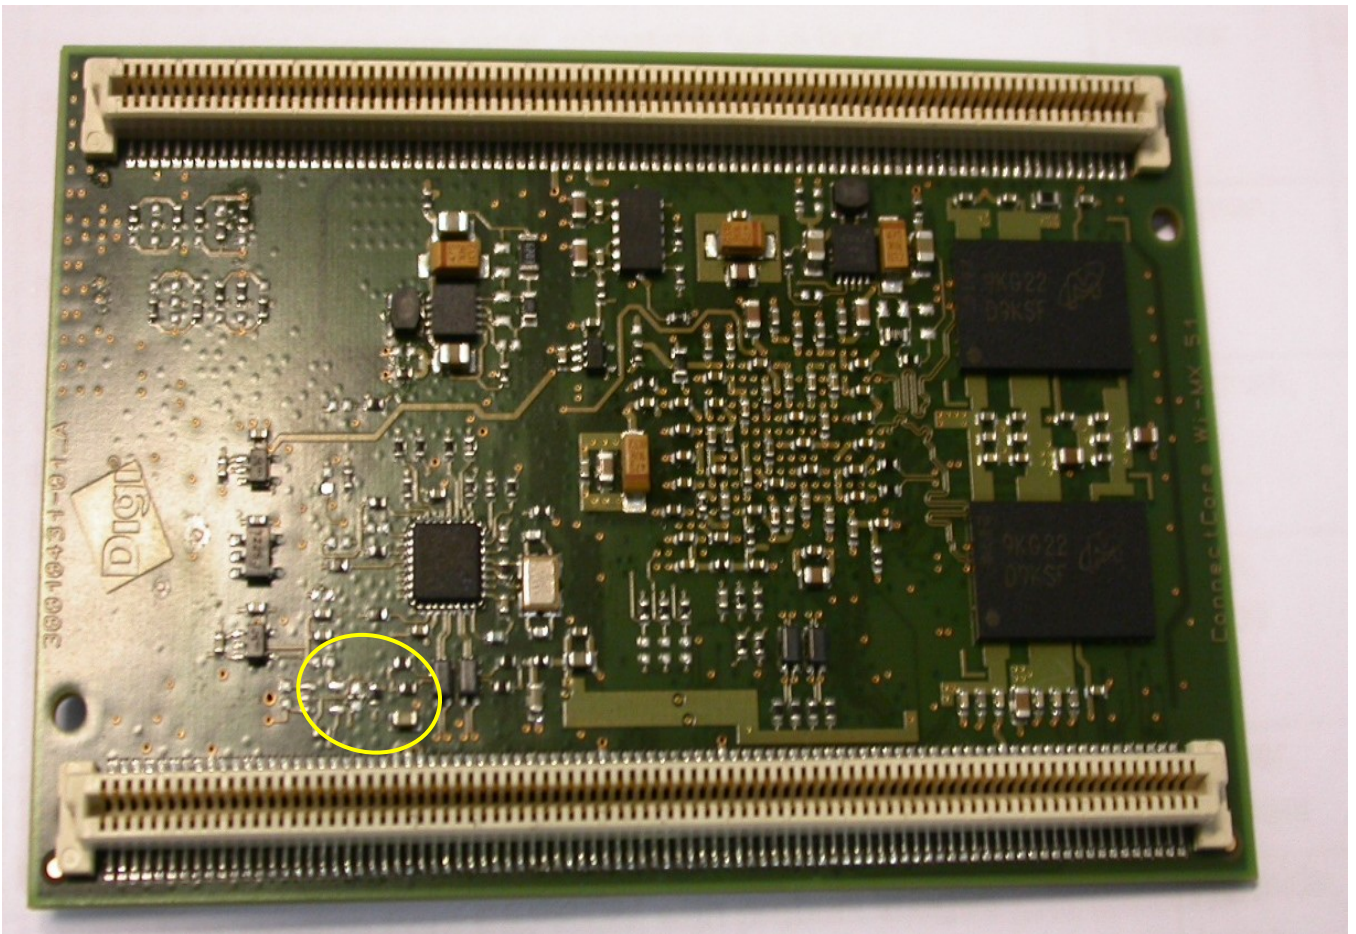
Figure 2: Identify general area of resistor location (bottom of module)

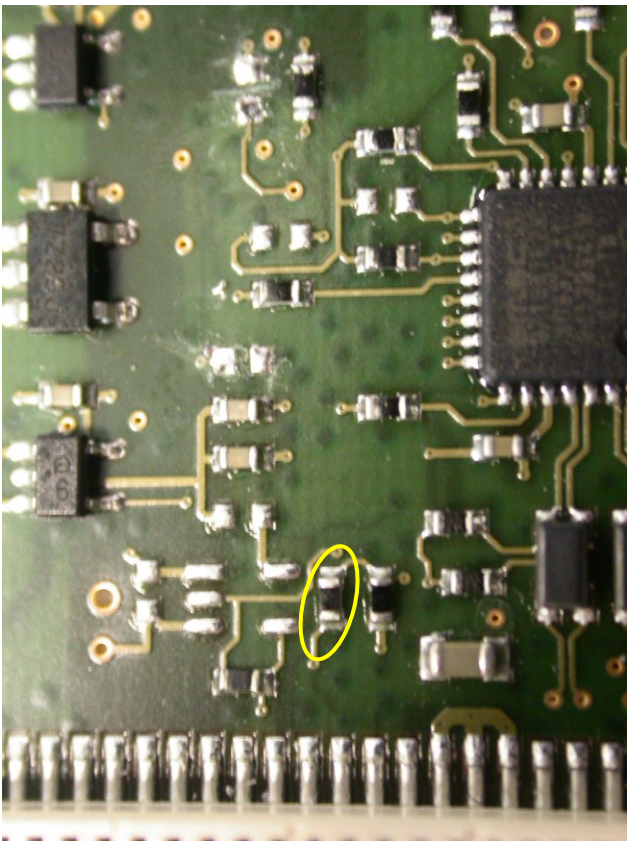
A resistor component population issue prevents the module from booting properly when the HDMI interface on the development board is used.

Figure 3: Close-up of resistor (R99) to be removed

The 0R series resistor R99 must be depopulated in order to enable the HDMI interface on the development board.

Please note that even though the removal of the resistor is a minor modification, it should only be handled by an experienced individual familiar with the manual removal of surface mount components.

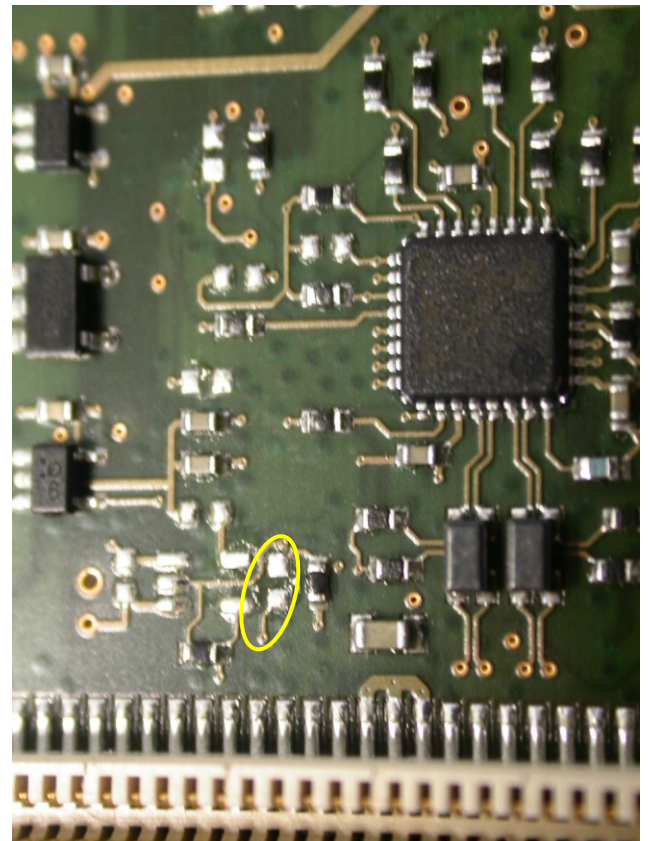
Figure 4: Close-up after resistor depopulation
