Test a WR41v2 Router

How to test a WR41v2 router step by step.

Technical Support
March 2016

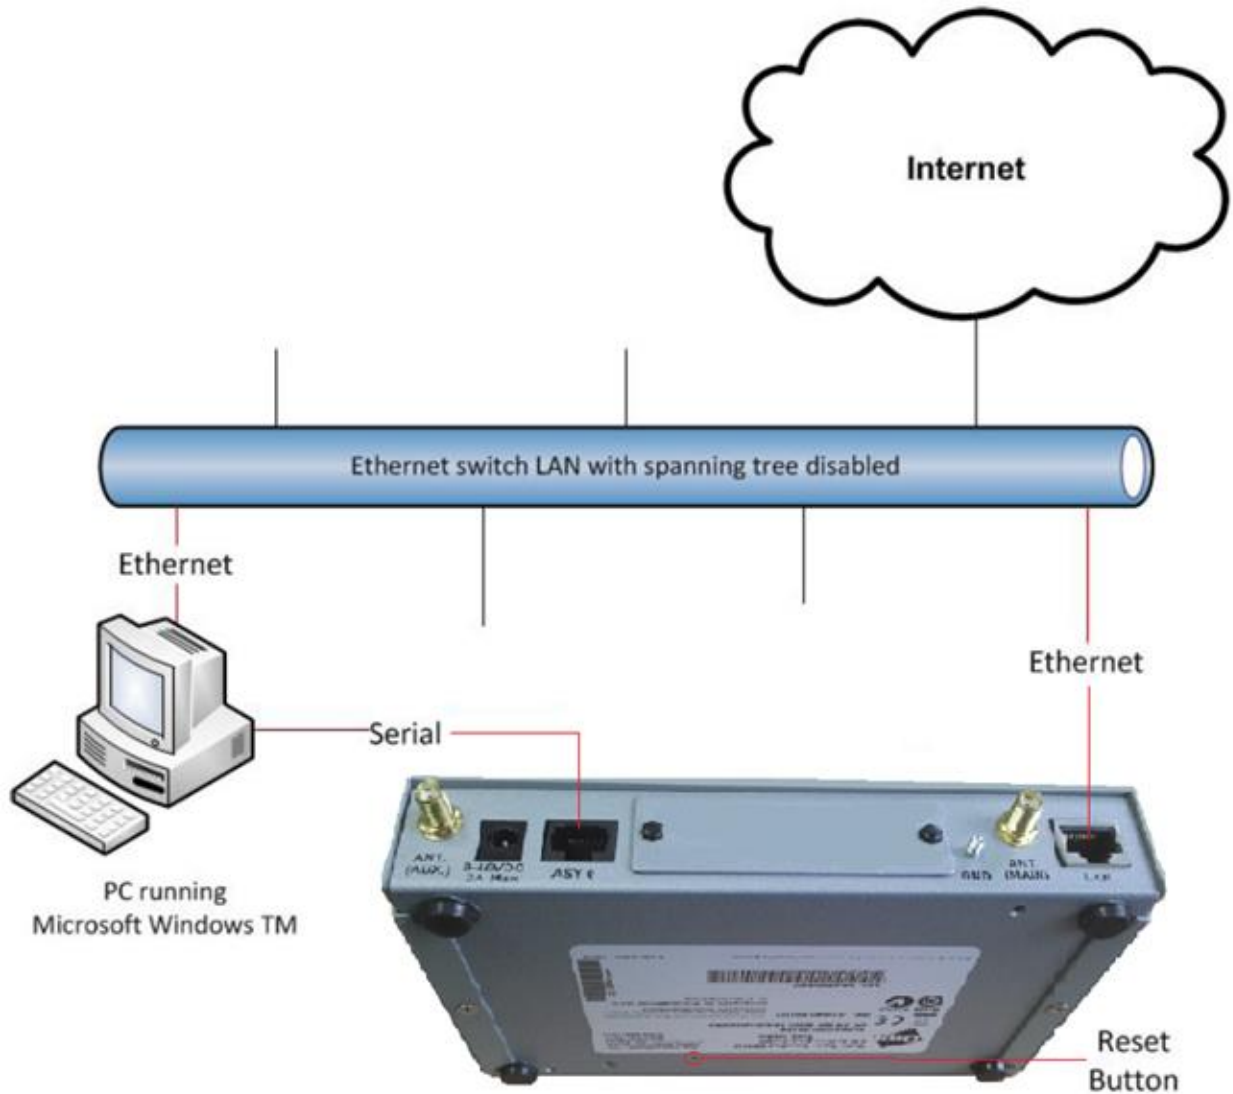
Set up the test equipment as described below.

- Connect LAN 0 of the WR41V2 to the switch/hub.
- Connect “ASY 0” the WR41V2 to the PC’s serial port 0 ideally “COM 1”.
- The Internet connection is optional and will be useful if help is required during this process from Digi Technical Support.
- Please note that the Ethernet switch/hub must not have the spanning tree protocol enabled. It is possible to use another appropriately configured WR41V2 as a switch/hub.
- It is essential that the PC’s Ethernet communication interface is configured correctly and has an IP address. The best strategy is normally to connect both your PC and the WR41V2 to your normal office LAN.
- Locate a suitable implement to depress the reset button when required.

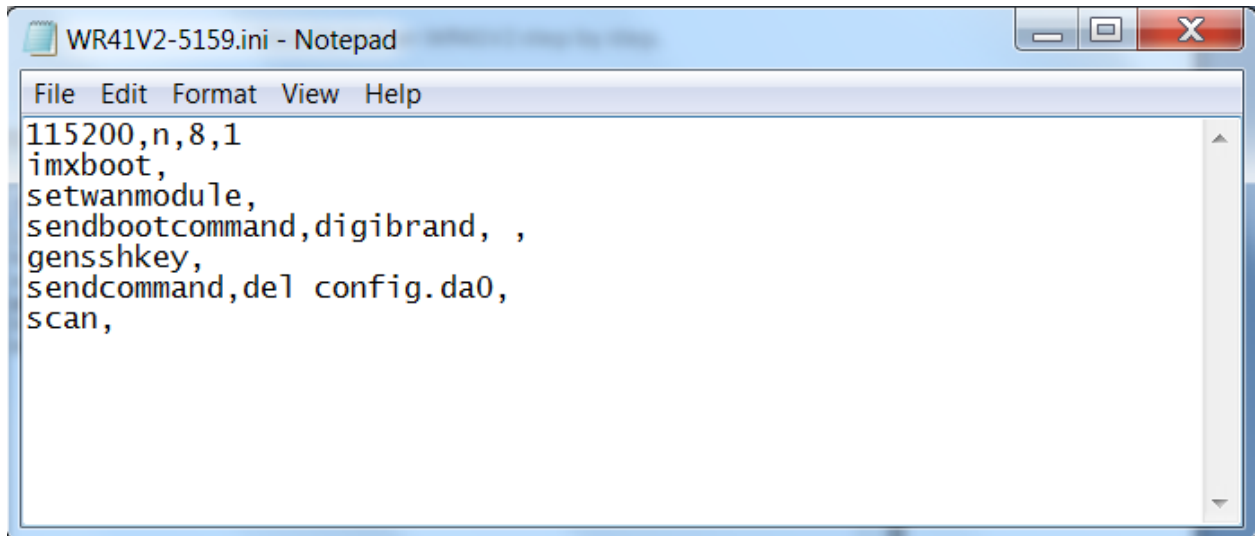
- Next download the following file: <http://transport.digi.com/downloads/imxtest.zip>
- Extract the contents of the zip file to a folder in the root directory of the test PC.
- Download the latest WR41V2 Flashwriter zip file and extract the contents to a single folder on your PC: <http://transport.digi.com/digi/firmware/flashwriter/XXXX/WR41v2/WR41v2-XXXX.zip> where **XXXX** is the current firmware version.
- Open the .ini file extracted and add the following text to the second line (be sure to include the comma):
imxboot,

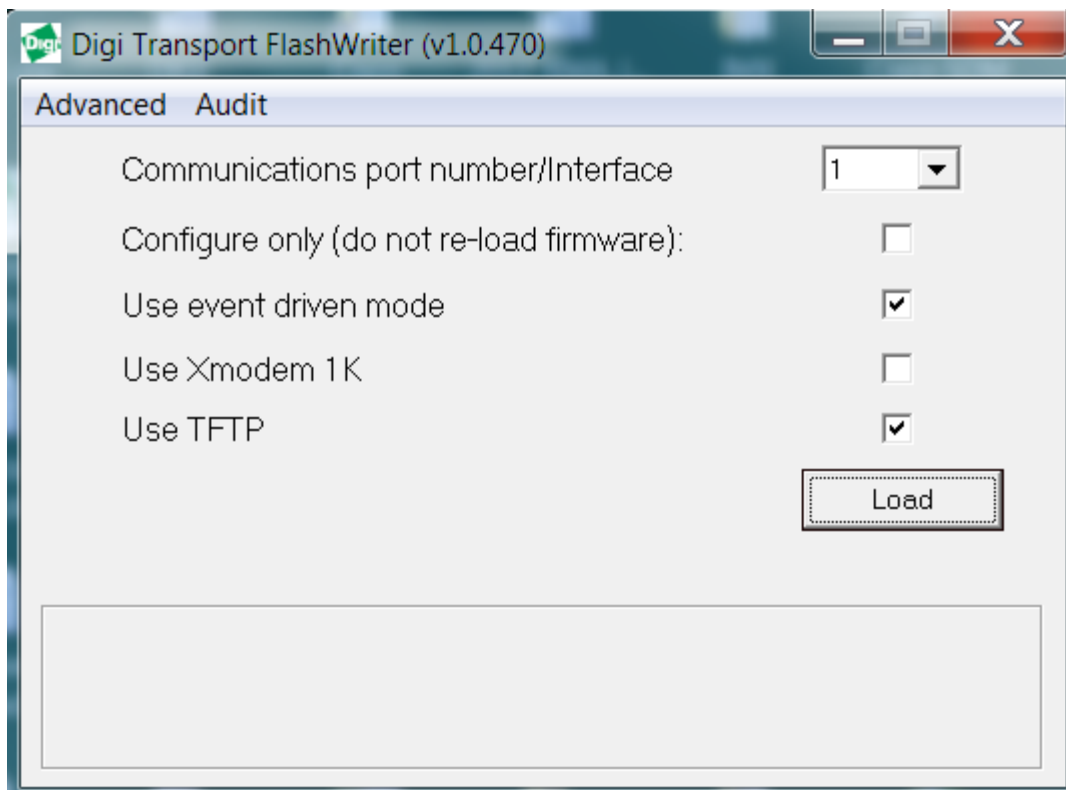
Launch Flashwriter from the start menu. Select the communications port number (PC comm. port number) to which the WR41v2 is connected. (On most PC's with a built in serial port, this will be "1" OR "2". Leave the other settings are their default values (TFTP and Event driven mode ONLY ticked):

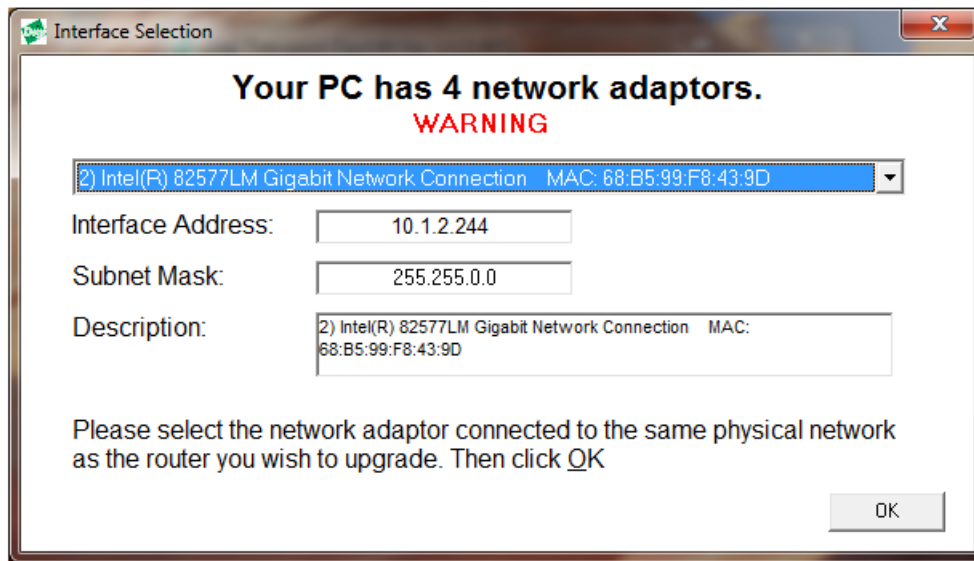
If your PC has more than one network adapter, be sure to select the one that represents the connection to LAN illustrated in section 3. If your PC only has a single network adapter this screen will not appear:

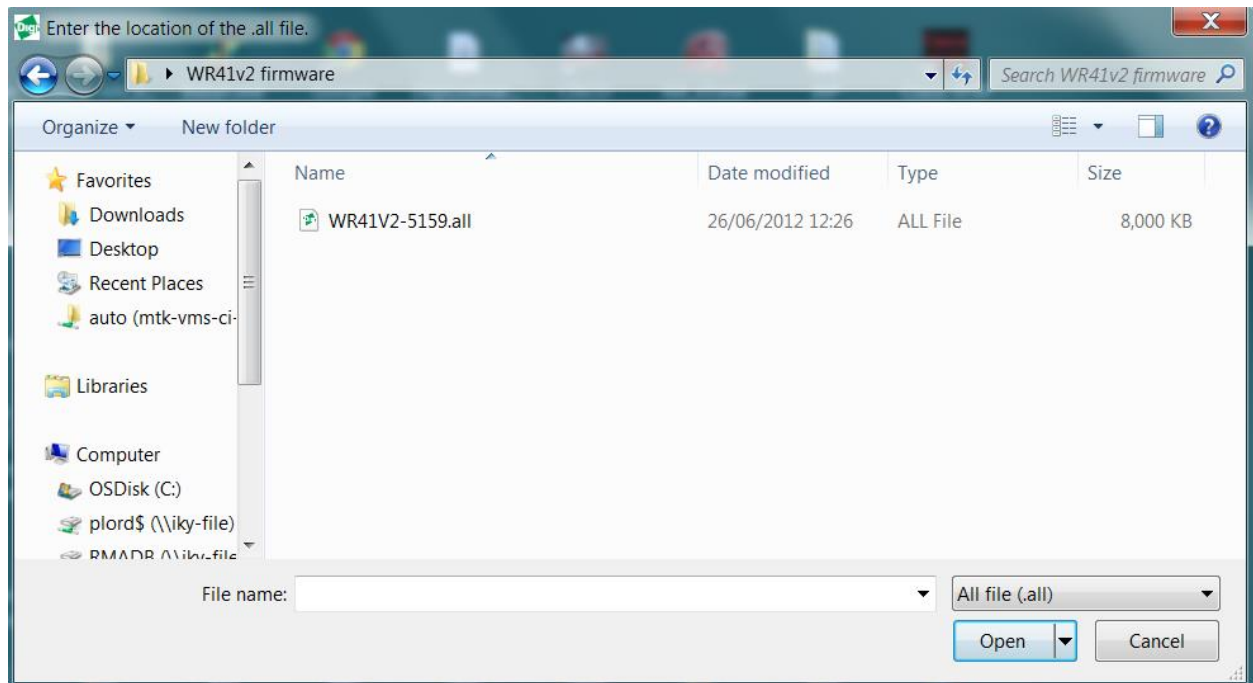
In the file dialogue, select the “ALL” file you extracted from the ZIP earlier:

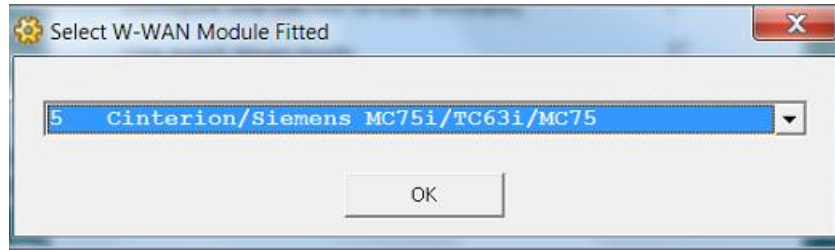
The following message will appear:

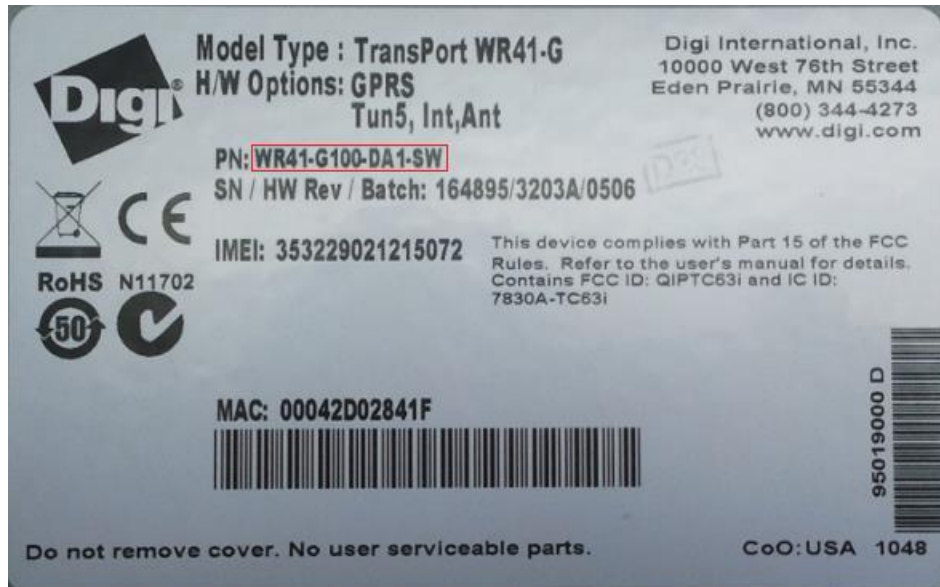
It is critical that the correct selection is made at this point. Note characters 6 and 7 of the part number (SKU) on the approval label. In the example below these are “G1”:

Refer to the following table to determine which selection to make:

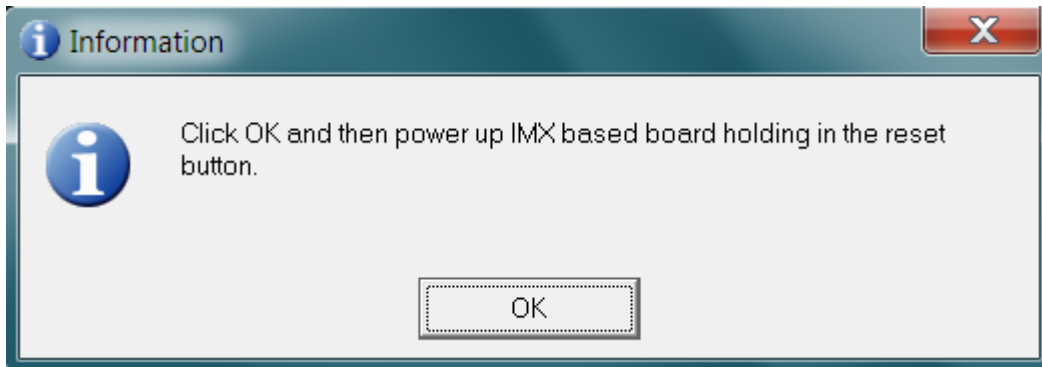
Once you click ok, the following message should appear:

Click “OK”, hold in the reset button (and keep it held) then plug in the power. This may take a bit of practise.

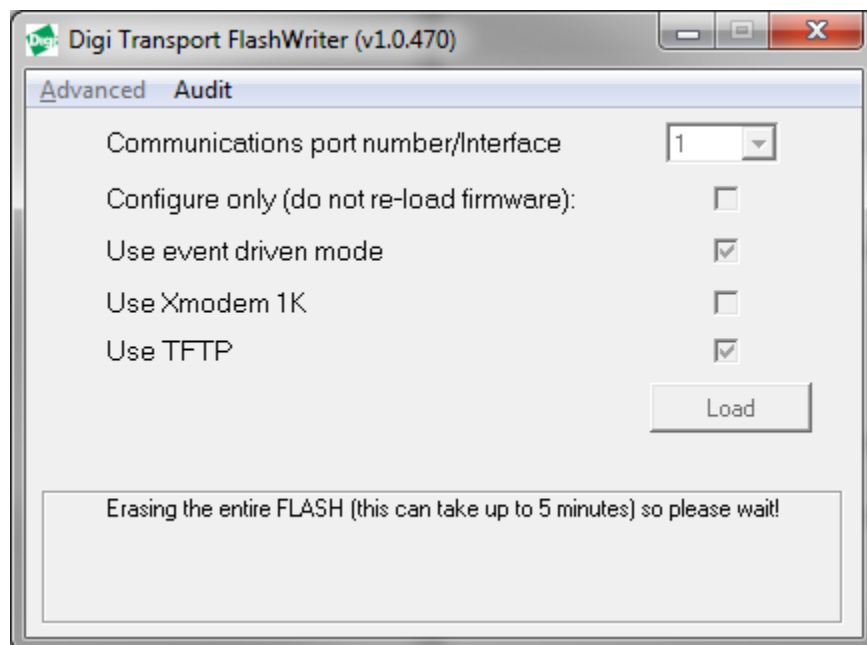
If you are successful then the following message will appear:

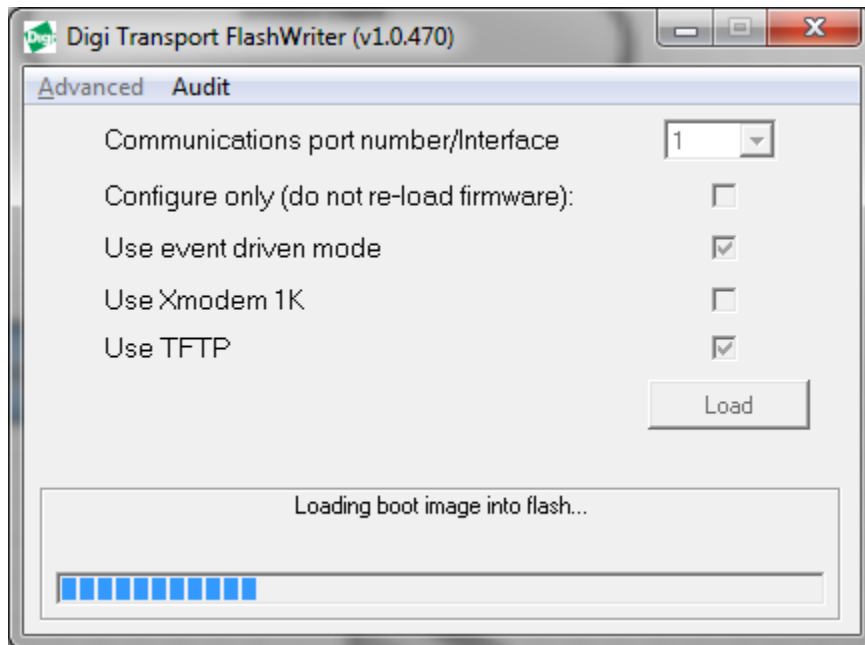
This step will take some time – please be patient. Once complete the boot image will be loaded into the flash:

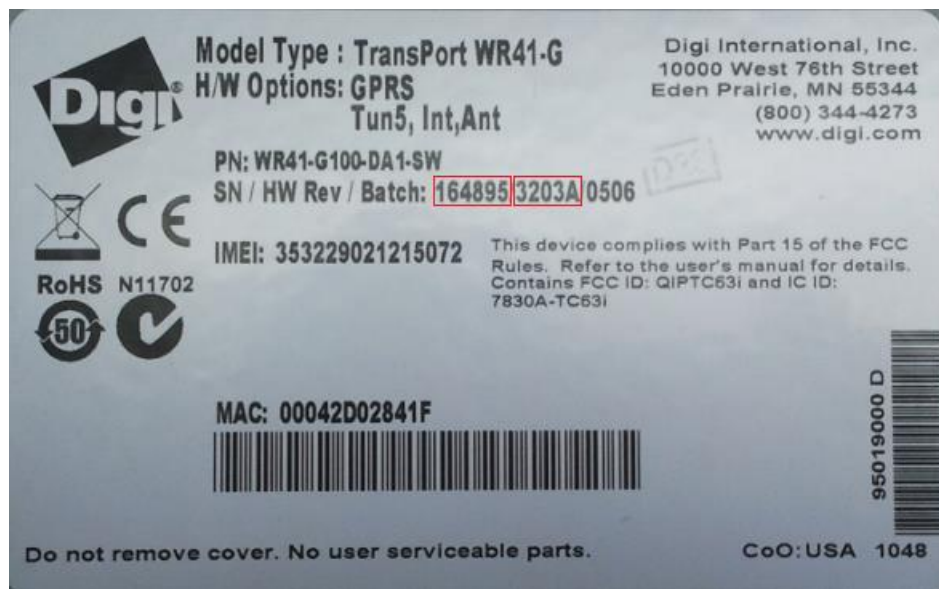
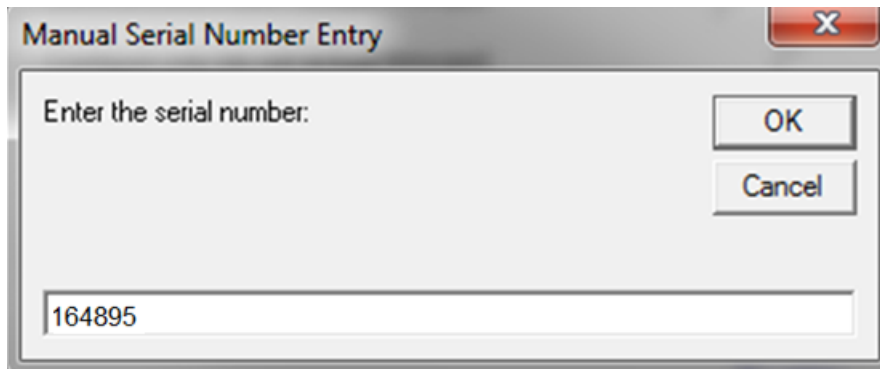
Eventually you should be prompted to enter the 6 digit serial number. (Refer to the label under the WR41V2 to find the correct serial number.)

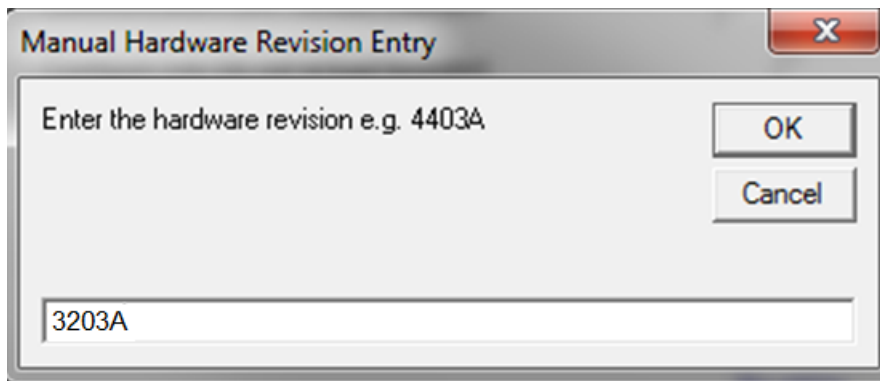
Next enter the hardware revision:

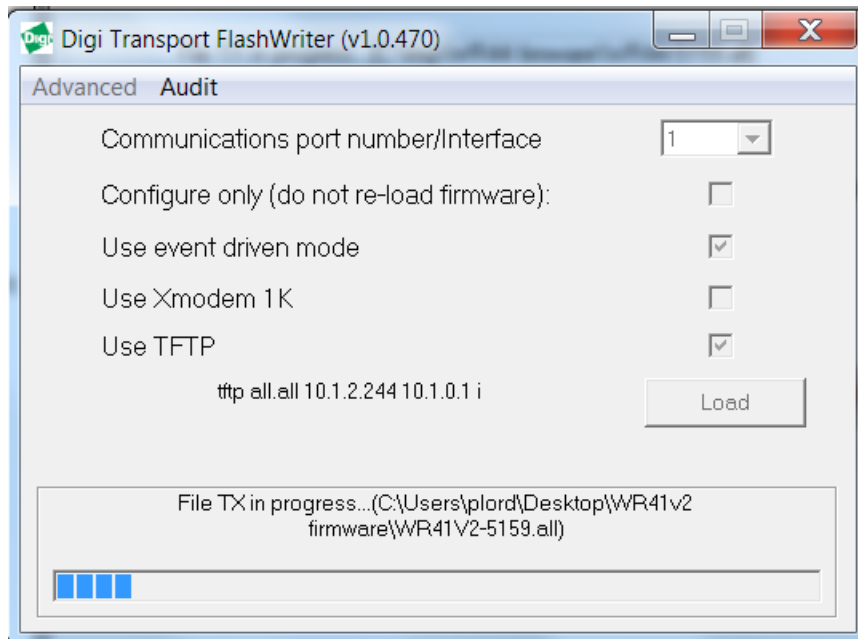
The .ALL file should start to load:

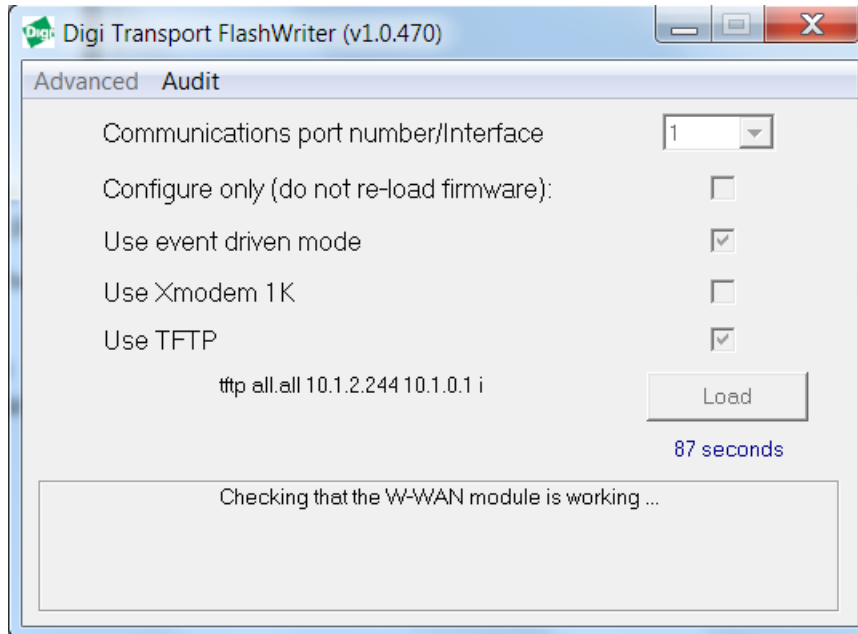
After reboot, it should check the interface to the W-WAN module (if one is fitted):

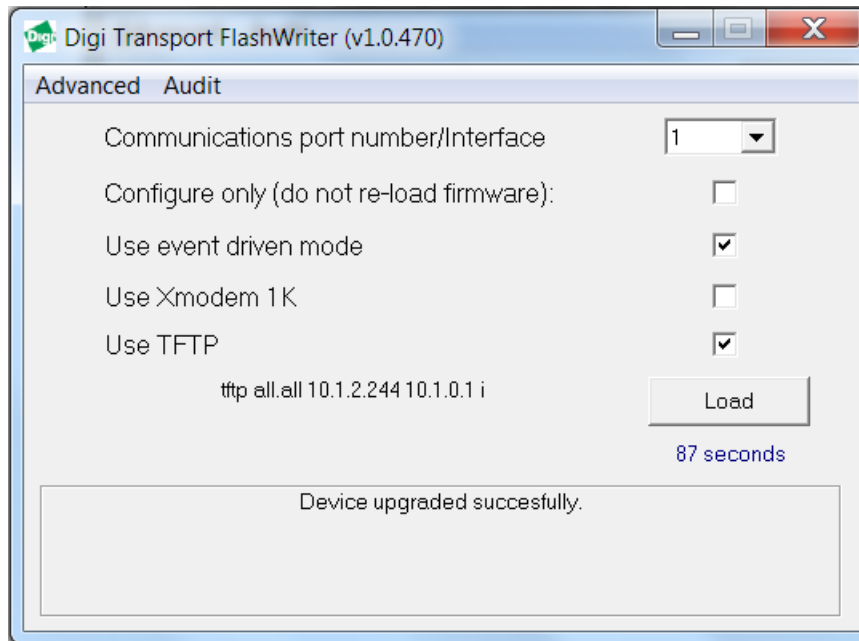
After this and other tests, it should report “Device upgraded successfully”:

This means the WR41V2 has been successfully flashed and correct communication with the internal radio module (if fitted) verified.

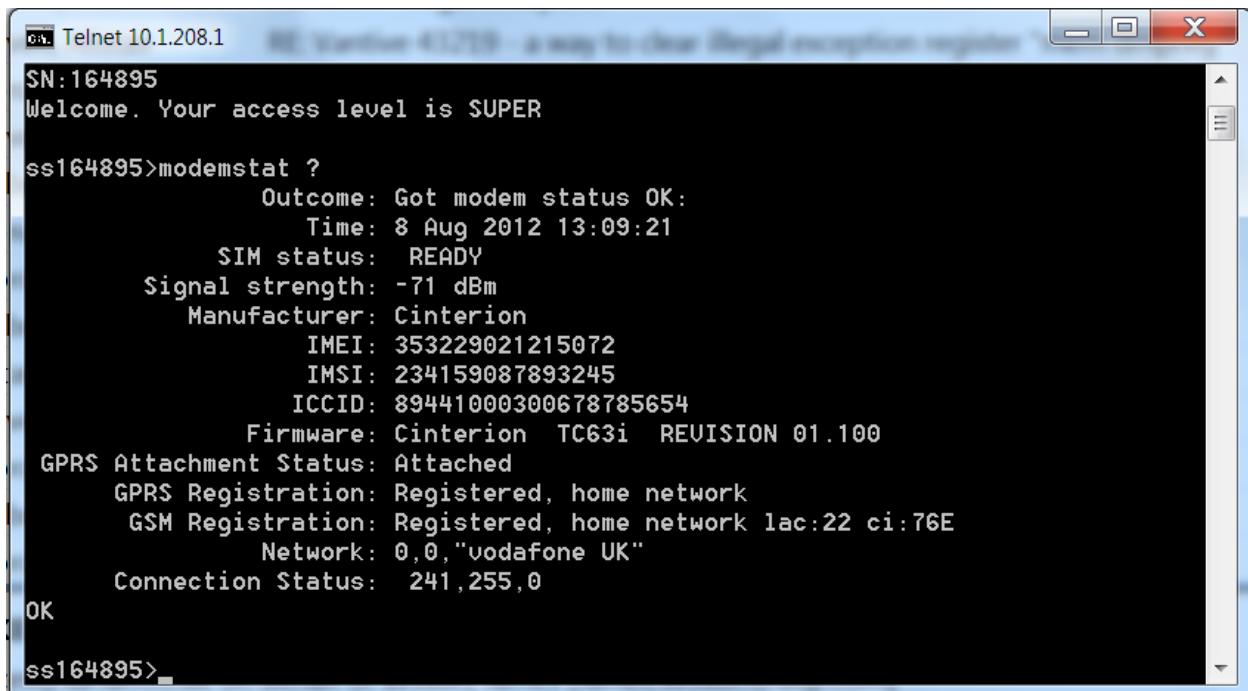
Whilst the internet link is still connected from step 7, access the CLI (Command Line Interface) and issue the following command: “modemstat ?”

A screenshot of a Telnet window titled "Telnet 10.1.208.1". The window shows a command-line interface with the following text:

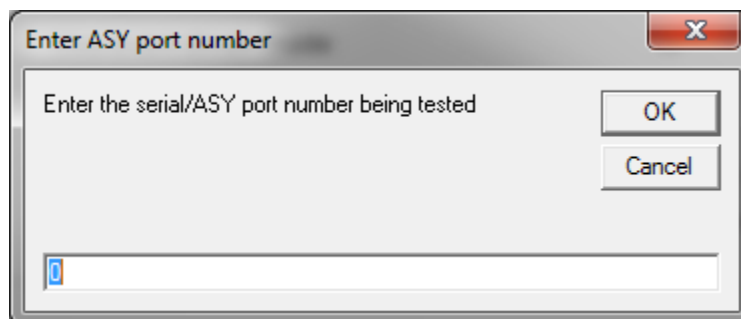
When the following prompt is received:

As you are testing “Serial 0” just click OK.

With the PC serial port still connected to “Serial 0” of the WR41v2, launch Flashwriter again, ensure that the correct PC comm. port number is selected and click on “Check Serial” from the Advanced menu of FlashWriter.
